A preliminary report about structural damages to RC/PC buildings in Kumamoto Earthquake

In order to investigate the extent of damage to reinforced and/or prestressed concrete buildings located in the affected areas, a reconnaissance team from the Kyoto University reinforced and/or prestressed concrete structure research laboratory was dispatched to Kumamoto. This document is an initial brief report from the 2-day field survey. The exact locations and the names of inspected buildings are not included. Moreover, almost all the information described is based on inspections from outside of the buildings. Further detailed damage inspection requires permission from either the property owners or city authorities.

Inspection days: 14th and 15th of May 2016

Inspected areas: Kumamoto city, Kikuyo town, Kashima town, Uto city, and Uki city

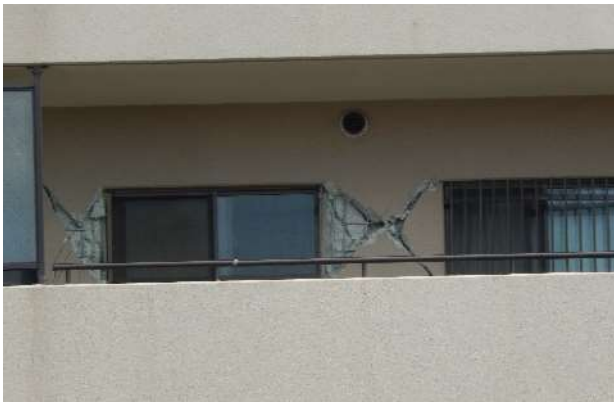
Damage: Concrete cracking and spalling were observed in non-structural walls of all the floors. No crack was seen in the walls of balconies. In the short span direction, or wall direction, some flexural-shear cracks in the shear walls were noticeable.

Damage in non-structural RC walls

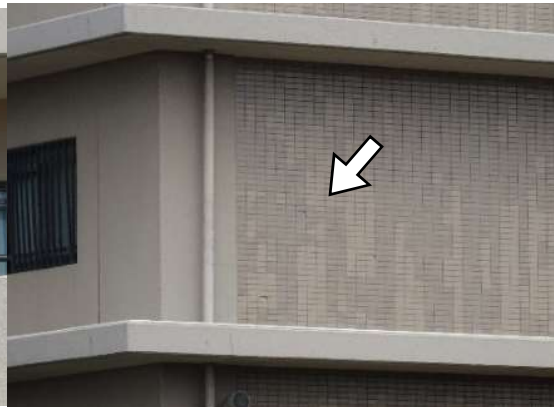
Damage in non-structural RC walls

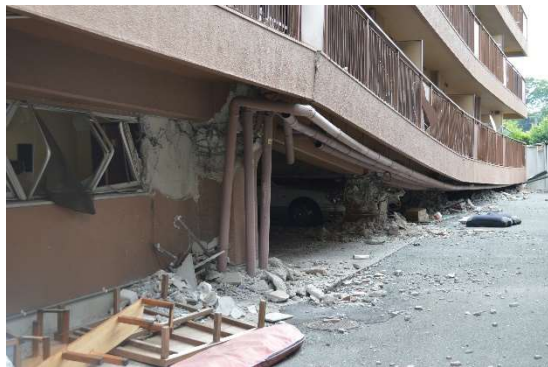
Damage: The columns of the open first story collapsed.

Column failed in the 1st floor

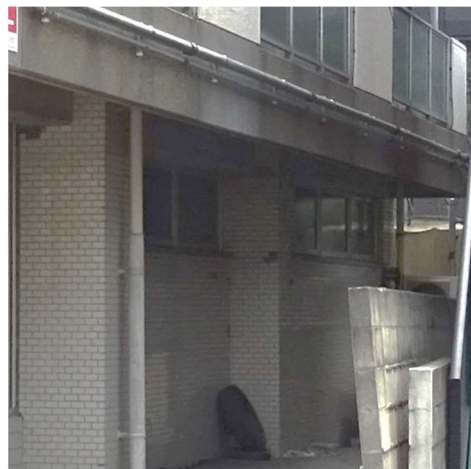
Damage: Damage was seen in the short columns of the first floor.

Damage in the short column

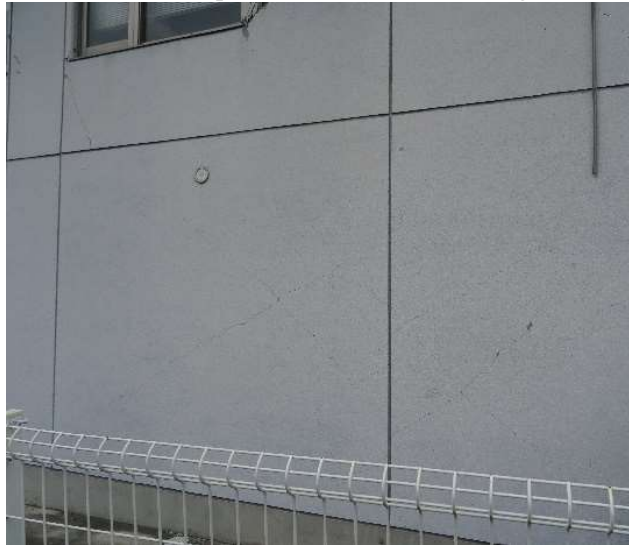
Damage: Shear cracks in the non-structural RC walls and shear walls of the first floor were observed. The hanging walls of the 3rd floor on the south side experienced concrete crushing.

Wall cracks in the 1st floor

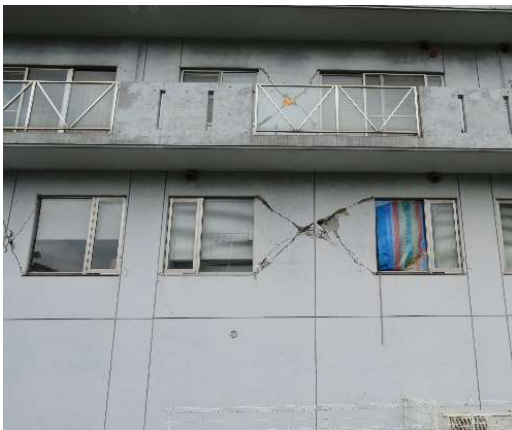
Diagonal cracks in non structural walls of the south side

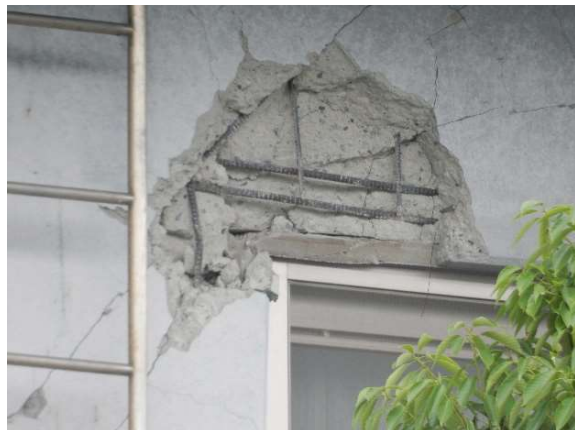
Concrete crushing in hanging wall on the 3rd floor

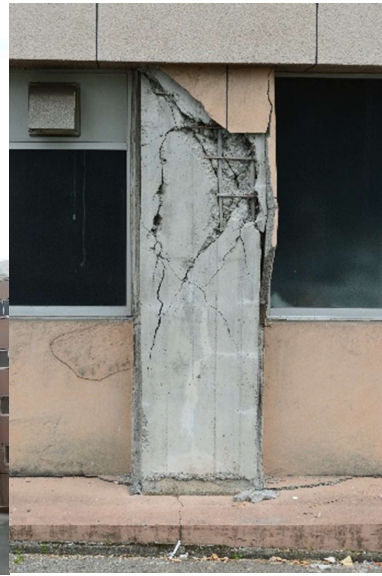
Damage: Shear failure was observed in the columns of 1st to 3rd floors. The longitudinal and transverse reinforcement consisted of plain round bars. The non-structural RC walls failed in shear.

Shear failure of the column

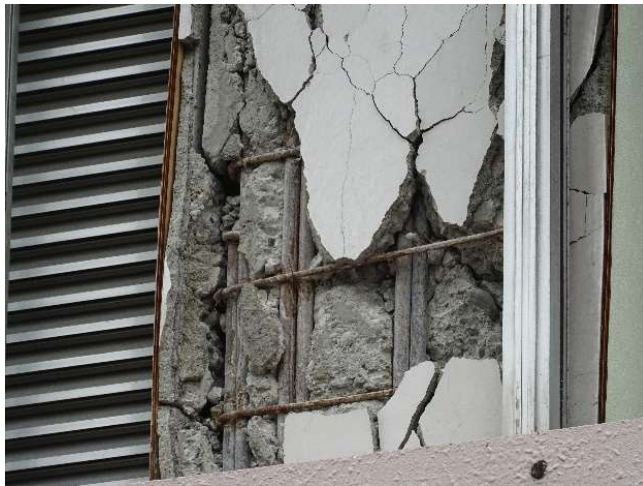
Shear failure of the column on the 2nd floor
(Plain round bars and lap splices are seen)

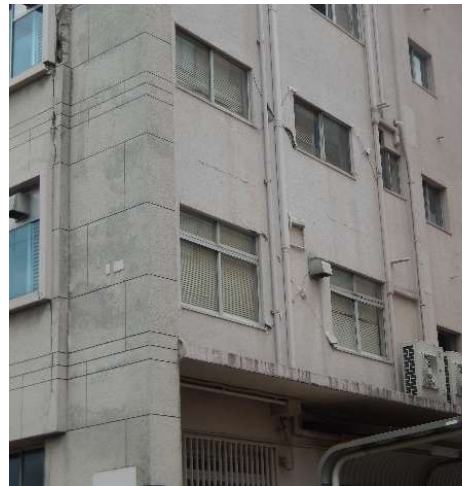
Shear failure of non-structural RC
walls

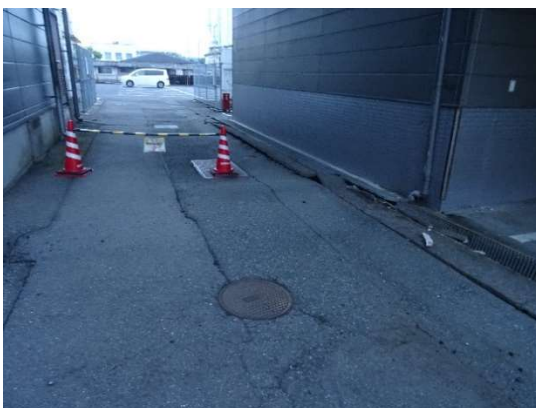
Ground condition

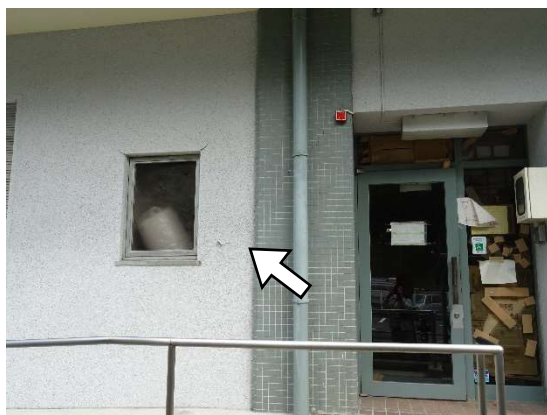
Crack in wing wall

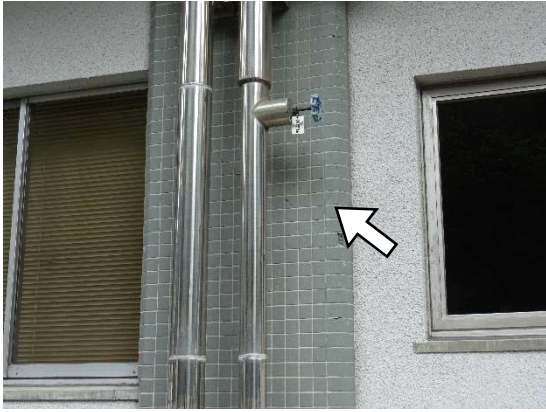
Shear crack in column

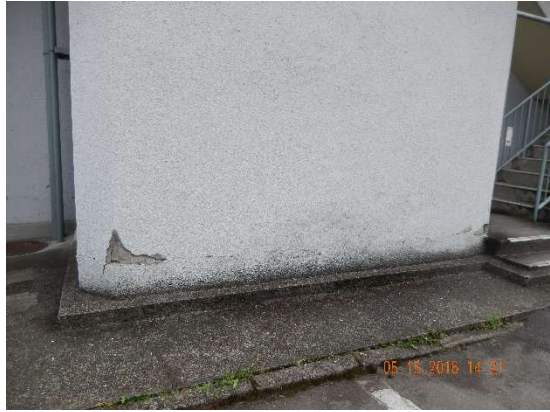
Horizontal crack at column base

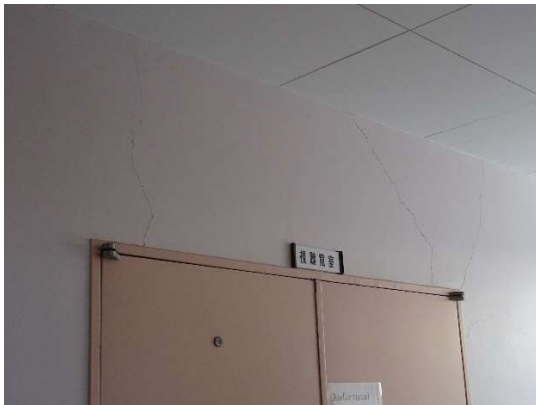
Damage: Almost all the non-structural RC walls had damage. The third floor, with no steel braces, had cracks with large width compared to cracks in the lower two floors. The maximum crack width of the shear walls in the longitudinal directions of the building at the first and third level were 0.45 mm and 3 mm, respectively.

Cracks in non-structural RC wall

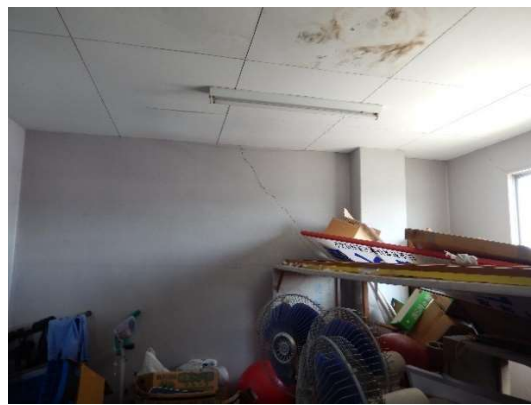
Crack in shear wall in 3rd floor

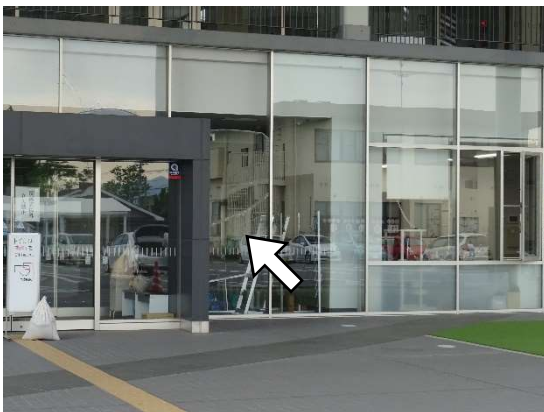
Damage: A crack in the glass facade next to the entrance was seen. Some settlement in the surrounding ground was noticed.

Crack in the glass facade

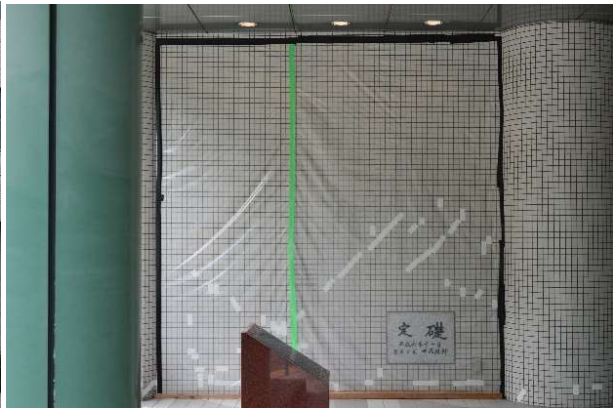
Damage: Shear cracks occurred in the shear walls of the 1st floor next to the entrance. Some cracks were noticeable around the perimeter of the circular opening of the non-structural RC wall.

Shear crack in shear wall

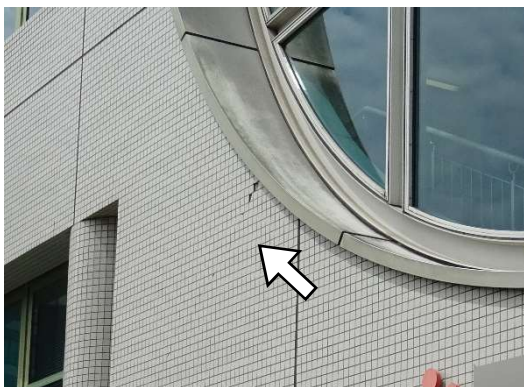
Shear crack in the external non-structural RC wall

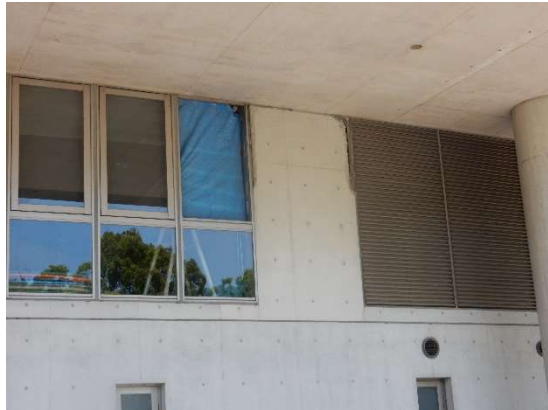
Damage: This facility is currently closed to public. Some concrete spalling occurred in the exterior RC walls of the office building. Ceiling materials in the gym were partially loosened and had fallen down.

Damage to exterior RC wall

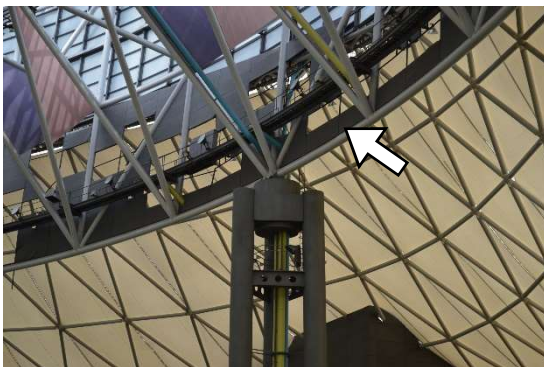
Falling of ceiling materials

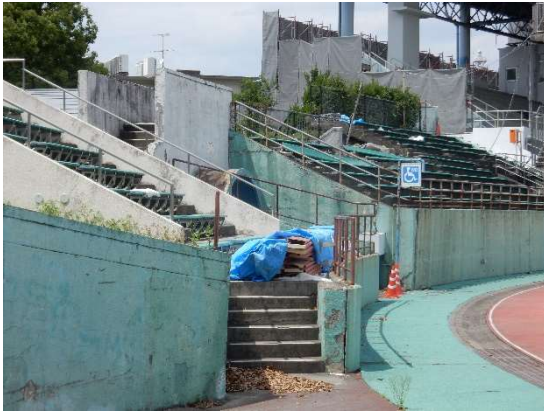
Damage: The main entrance of the facility was under seismic retrofitting when the earthquake occurred. The building was tagged as “unsafe” by post-earthquake temporary risk evaluation. Some retaining walls collapsed. The stand was severely damaged and the exterior walls accommodated extensive cracks.

Damage to stand

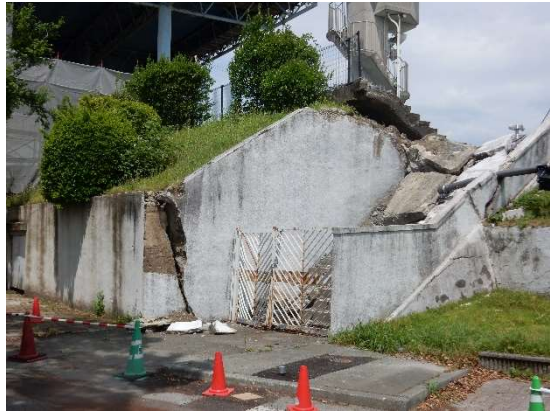
Damage to retaining wall

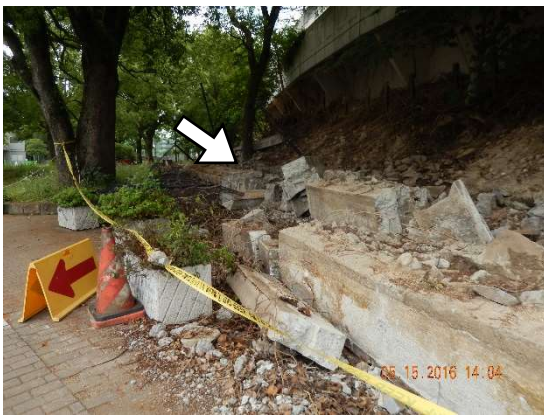
Collapse of retaining wall and surrounding ground.

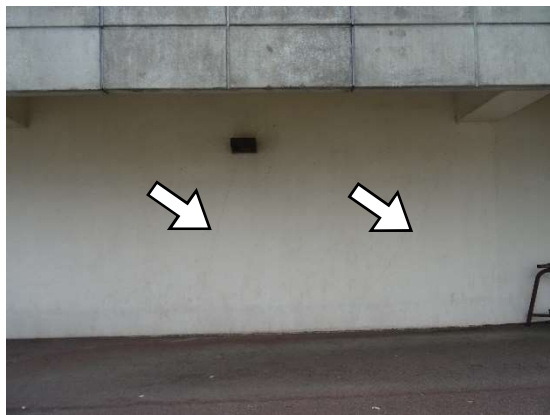
Crack in exterior walls

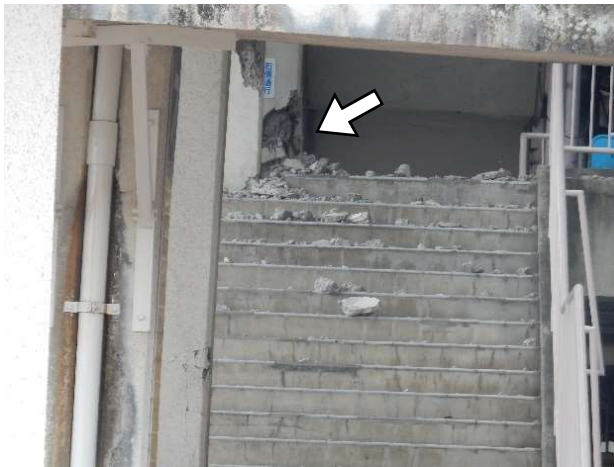
Damage: The whole structure was judged as “unsafe”. A number of RC columns of the stand which was built in 1968 suffered shear/flexural failure. In some steel frame structures the infill panel were either cracked or shattered.

Flexural failure at column base

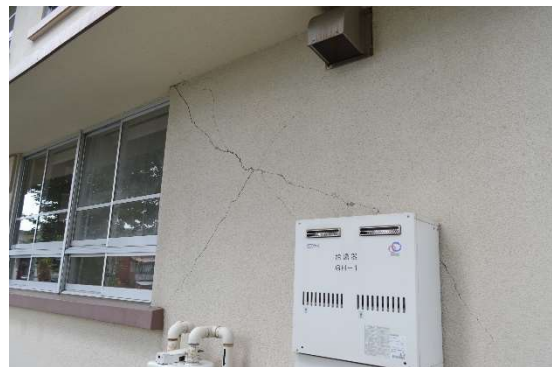
Damage: Damage at the expansion joint was significant. Some diagonal cracks were observed at the joints of the outer frames, but it was not confirmed whether these occurred due to the earthquake or not. Shear cracks were noticeable in the longitudinal direction of the building where the external PCaPC frames were attached to the existing building.

Cracks in external RC walls in non-strengthened direction

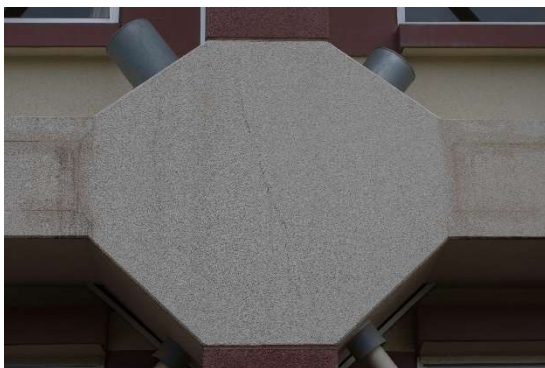
Crack at joint of retrofitting plane frame

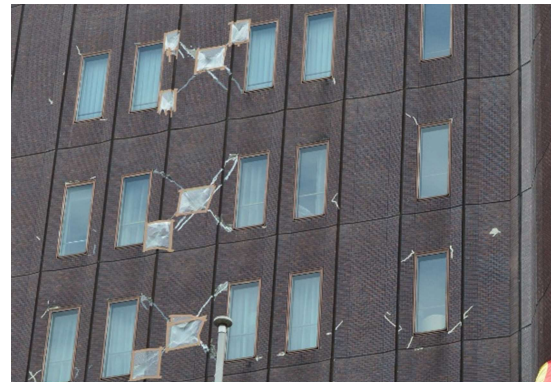
Damage: Extensive damage to the exterior RC walls was noticed.

Cracks in exterior RC wall

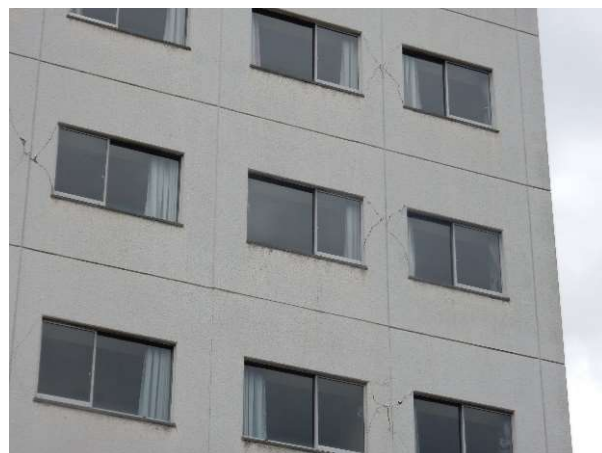
Damage: The building was apparently vacant. Extensive cracks in the RC walls between window openings were observed. In addition, some diagonal cracks were noticed in the beam above the entrance.

Diagonal cracks in exterior RC walls between window openings

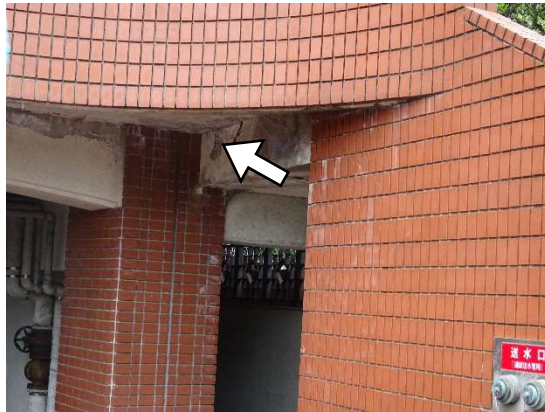
Shear cracks in the beam at the main entrance

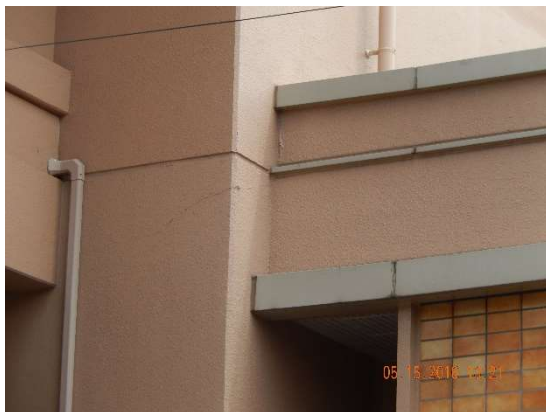
Damage: The building was open to public. Shear cracks were found in the external wall of the first story and the retrofitting frames. Moreover, cracks in the beam-column connections were seen.

Crack at beam-column connection

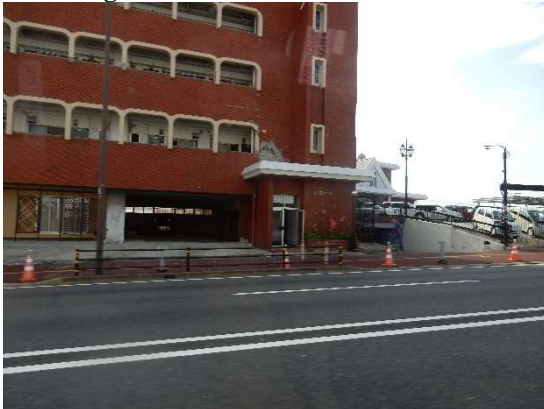
Cracks in the 1st and 2nd floors (Kumamoto city, central district)

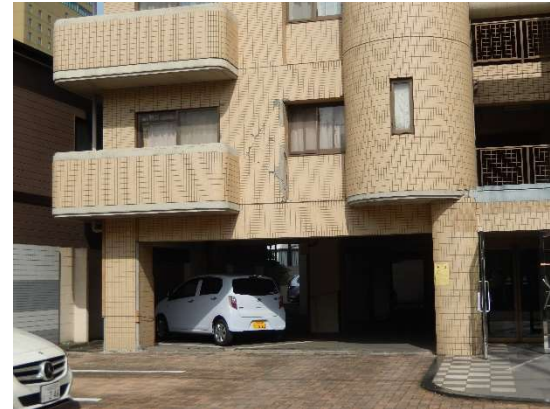
Cracks in non-structural RC walls of the 2nd floor (Kumamoto city, central district)

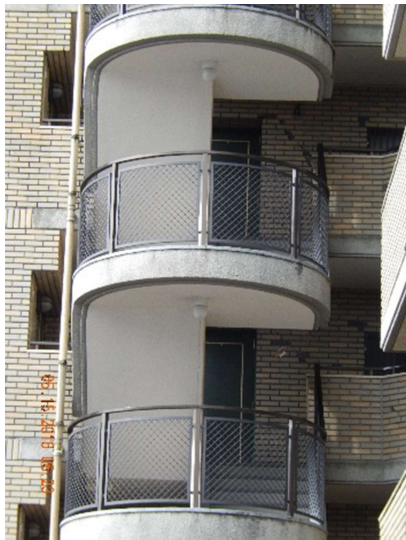
Non-structural RC walls cracked (Kumamoto city, central district)

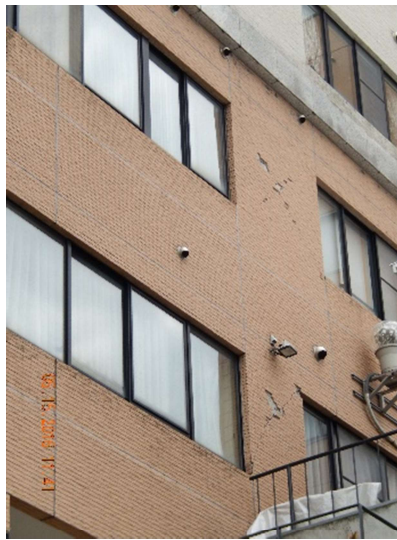
Diagonal cracks in non-structural RC wall (Kumamoto city, central district)

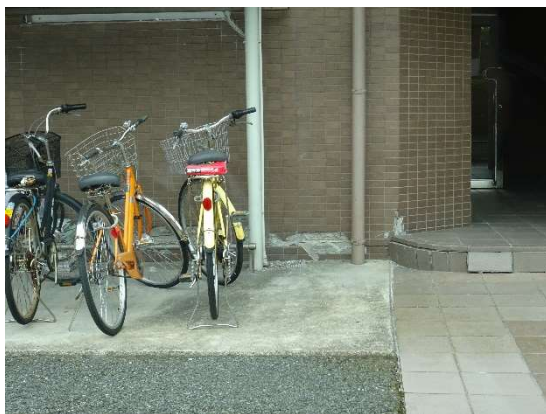
Cracks at the base of shear wall (Kumamoto city, East district)

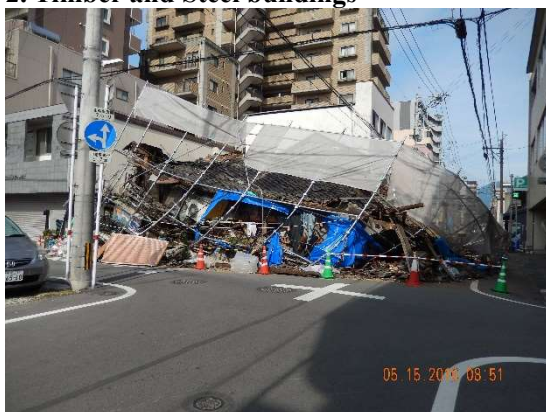
Collapse of a wooden house (Kumamoto city, central district)

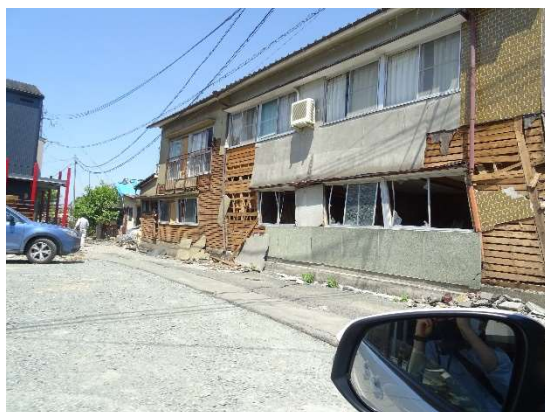
Significant damage in a wooden house, Kamimashiki district, Mashiki town

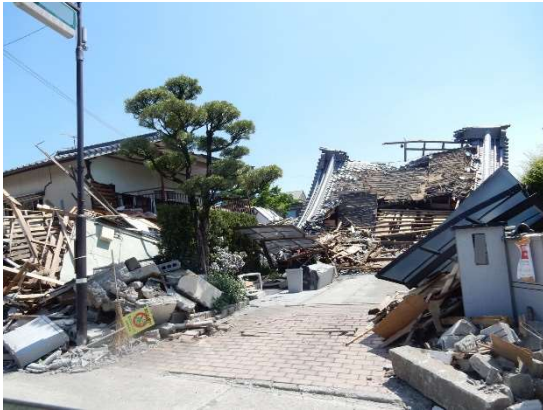
Collapse of a wooden temple (Kamimashiki district, Mashiki town)

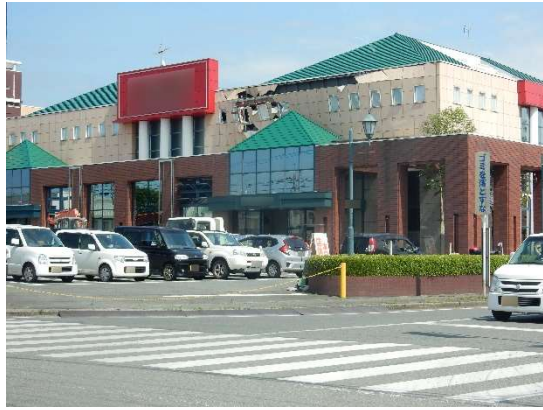
Damage to exterior panels and falling of window glasses (Kumamoto city, Eastern district)

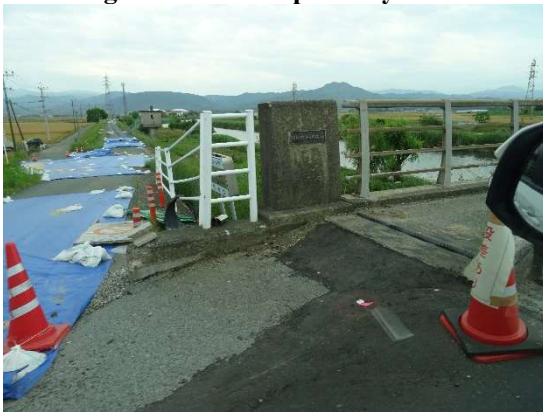
Elevation difference between bridge and roadway (Kumamoto city, Eastern district)

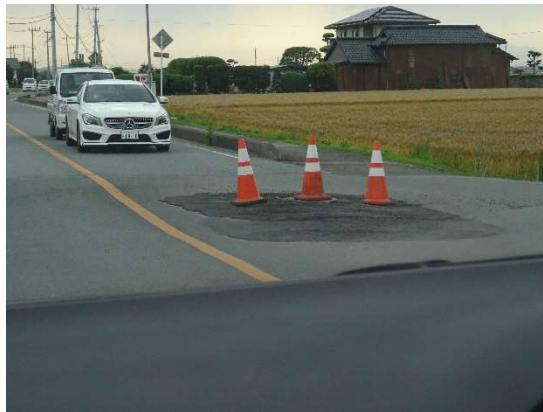
Sinking of pavement (Kumamoto city, Eastern district)

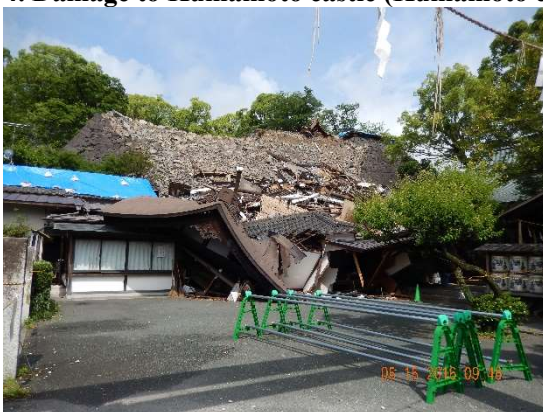
Collapse of a shrine

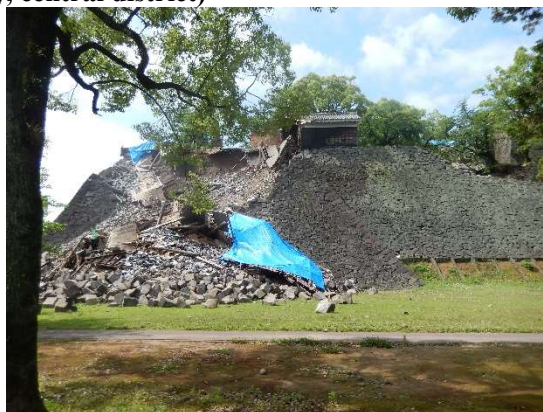
Damage to stone retaining wall (Kumamoto city, central district)

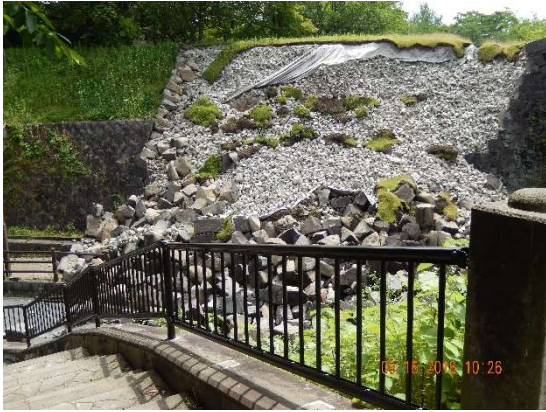
Damage to stone retaining wall

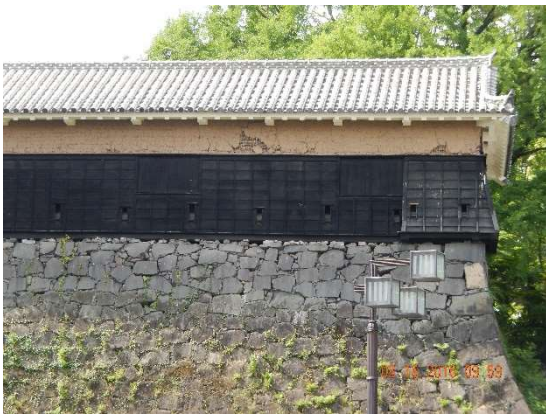
Spalling and cracking in the soil wall

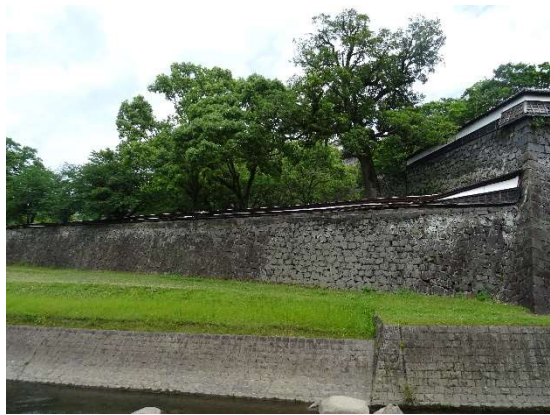
Damage to stone retaining wall

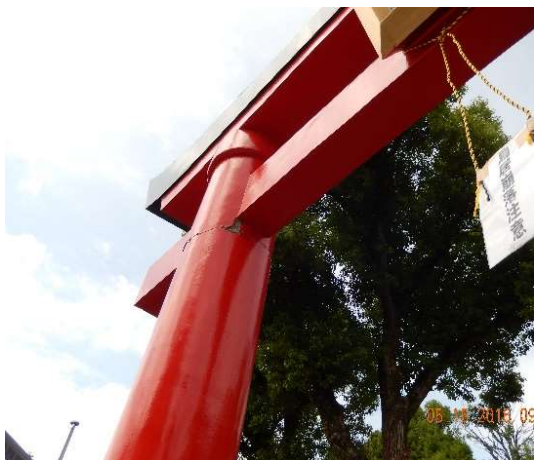
Damage to RC structure of the entrance gate to a shrine (Kumamoto city, central district)

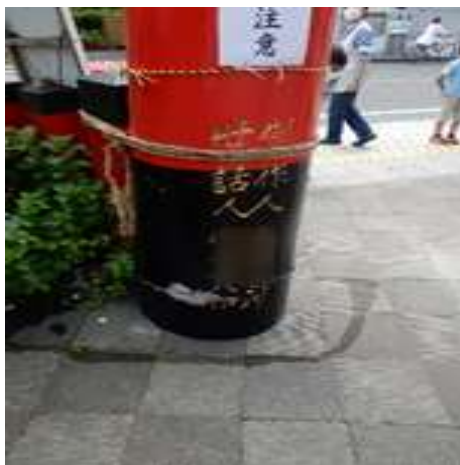
Damage to RC structure of the entrance to a shrine gate (Kumamoto city, central district)

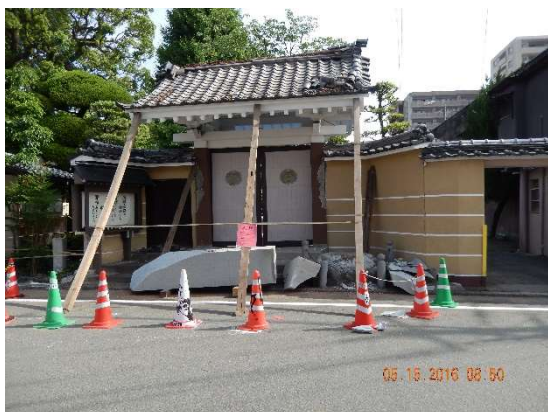
Damage to a temple gate (Kumamoto city, central district)

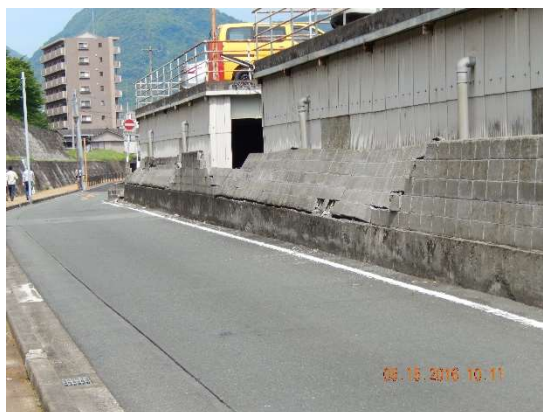
Collapse of concrete block wall (Kumamoto city, central district)
