A preliminary report about structural damages to RC/PC buildings in Kumamoto Earthquake

In order to investigate the extent of damage to reinforced and/or prestressed concrete buildings located in the affected areas, a reconnaissance team from the Kyoto University reinforced and/or prestressed concrete structure research laboratory was dispatched to Kumamoto. This document is an initial brief report from the 2-day field survey. The exact locations and the names of inspected buildings are not included. Moreover, almost all the information described is based on inspections from outside of the buildings. Further detailed damage inspection requires permission from either the property owners or city authorities.

Inspection days: 14th and 15th of May 2016

Inspected areas: Kumamoto city, Kikuyo town, Kashima town, Uto city, and Uki city

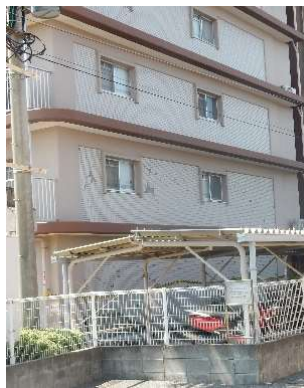
Damage: Even though the building was judged as “unsafe” for reoccupation, some families were living in their houses. In the south wing, severe damage to the shear wall of the first floor was observed. Concrete spalling at the base of the boundary column was significant. Several cracks were noticeable in the shear wall of the upper stories as well. In the longitudinal direction of this wing, failure of the shear wall as well as buckling of the longitudinal rebar of one column was significant. The out-of-plane shear cracks observed in the column were consistent with the occurrence of out-of-plane shear cracks in the shear wall. In the north wing, shear cracks in the columns and wing walls were clearly seen from a distance.

Visible cracks in walls (south wing)

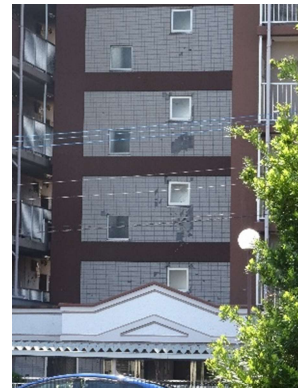
Observed damage in non-structural walls (staircase block)

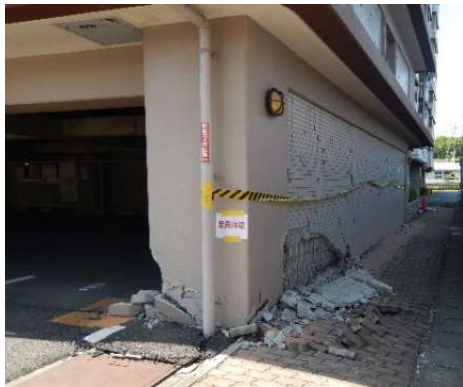
Spalling of tiles and concrete cover from wall (south wing)

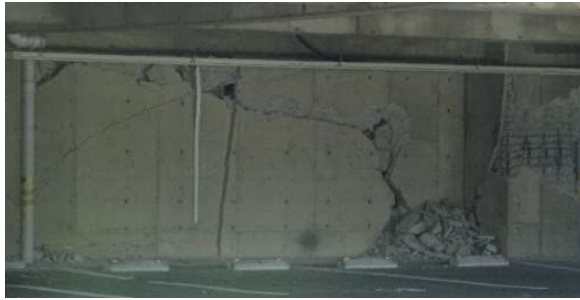
Damage to wall and column in longitudinal direction (1st floor of south wing)

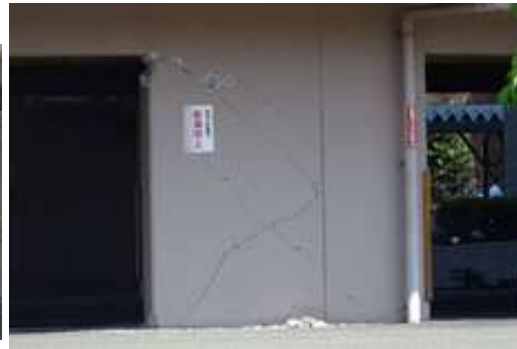
Damage to column and wing wall (1st floor of north wing)

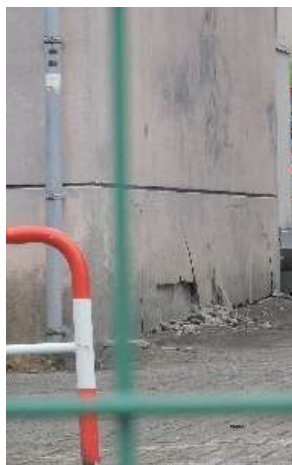
Damage: Spalling of mortar finishings at the wall base of the first floor was observed. Large cracks in the retaining walls were seen.

Spalling of finishing at wall base

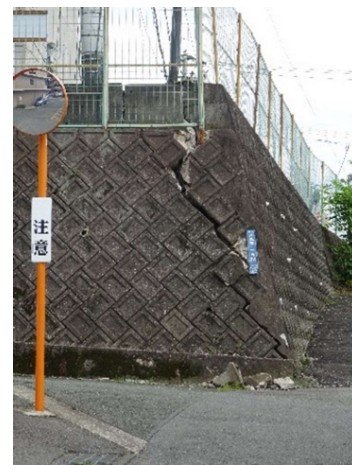
Crack at retaining wall

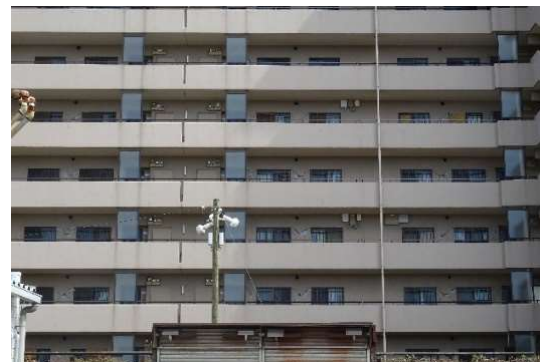
Damage: Concrete cracking and spalling were observed in non-structural walls of all the floors. No crack was seen in the walls of balconies. In the short span direction, or wall direction, some flexural-shear cracks in the shear walls were noticeable.

Damage in non-structural RC walls

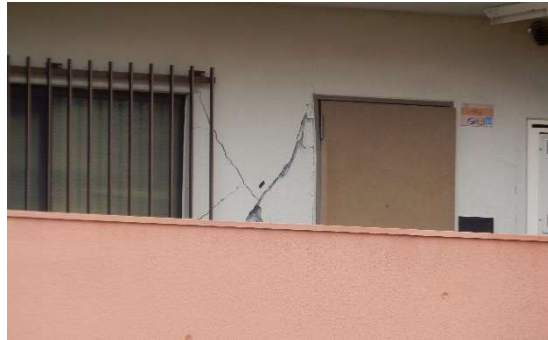
Damage: Diagonal cracks in non-structural walls were observed up to the 7th floor .

Diagonal cracks in non-structural wall

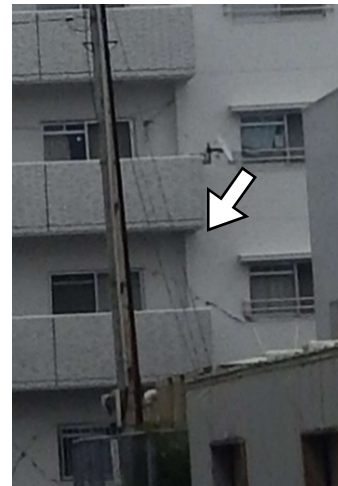
Damage: The non-structural walls on the lower floors cracked in shear, and some shear cracks extended into the adjacent columns.

Shear cracks in column

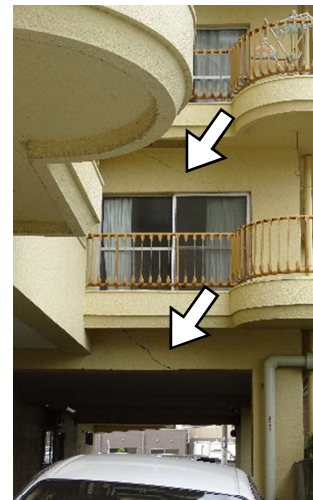
Damage: Shear cracks in the beams of 2nd and 3rd floors were observed.

Shear cracks in beams

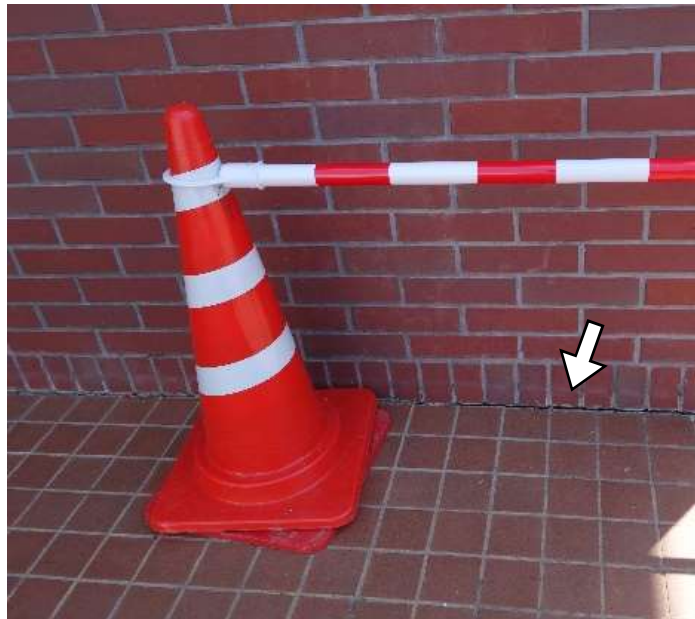
Damage: No damage was seen either in the attached PCaPC frames or the main structure. A 1.0 cm uplift was seen in the wall base in the eastern wing. Shear cracks in non-structural walls of the long side inside the building were observed.

1.0 cm uplift at the wall base

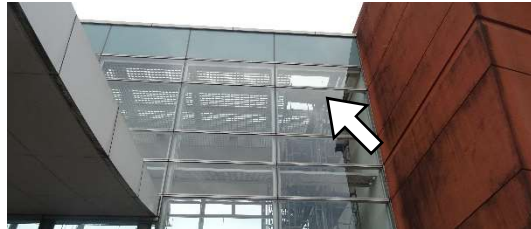
Damage: Some material fallings were seen at the entrance hall near the ceiling. The ground outside the building deformed.

Ceiling materials

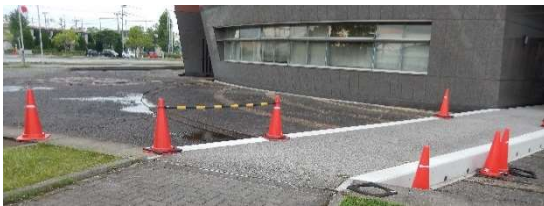
Deformation of the ground outside

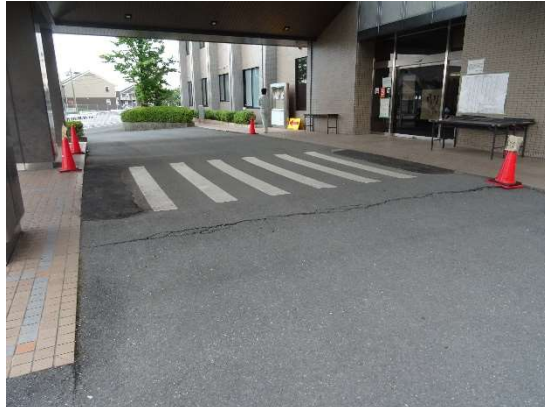
Damage: The building was operational and in service. No serious damage was observed. The ground outside was partially settled.

Partial ground settlement at the main entrance

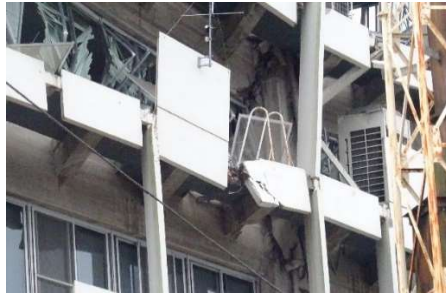
Damage: The 4th story partially collapsed. The crushing in beam-column joints at several places of the 3rd and 4th stories was observed. The crushing of a joint in the 4th story resulted in the upper part (column and slab) displaced downward. Due to the joint failure at the 5th floor, the beam in this floor deflected downward as well.

3rd and 4th floors

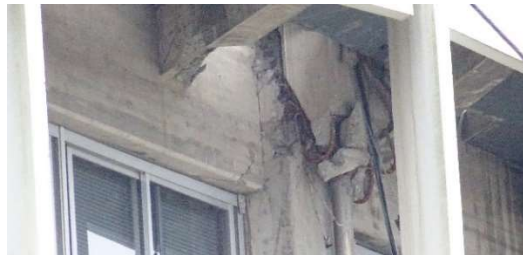
3rd floor column - 4th floor beam joint

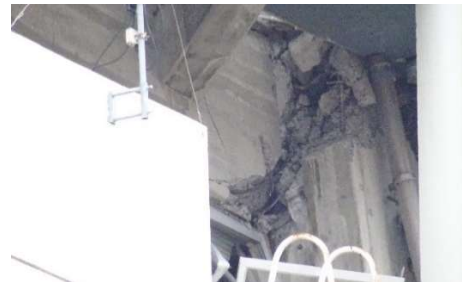
4rd floor column - 5th floor beam joint

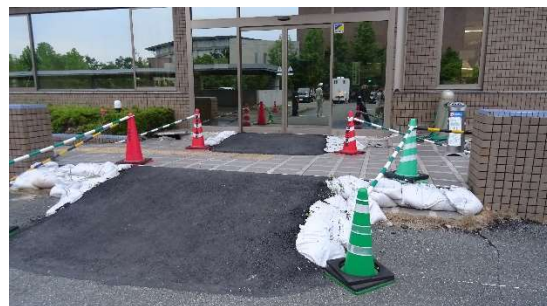
Damage: The building was operational and in service. Ground settlement was seen at several spots. Shear cracks were seen in the external walls in the short span side.

Ground settlement

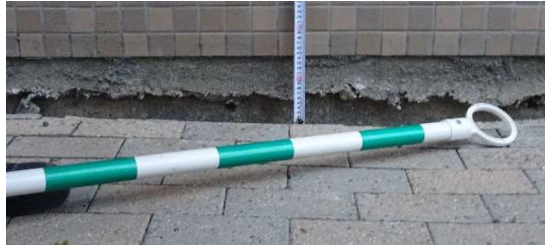
The annex building was a 3-story RC building, built in 2007. It was connected to the main building via a corridor in the 2nd floor. No damage was observed. However, a settlement of about 30 cm occurred in the ground.

Ground settlement

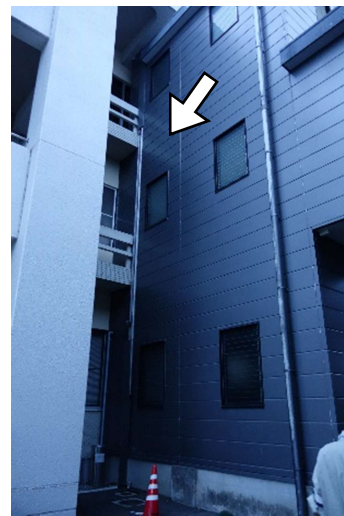
Damage: The main building was almost intact. Cover plates over the expansion joint between this main building and a neighboring steel structure was partially displaced. The PCaPC frame was connected to the existing building structure with a beam approximately 3000 mm long. In addition, ground settlement was observed.

Displaced steel cover of expansion joint

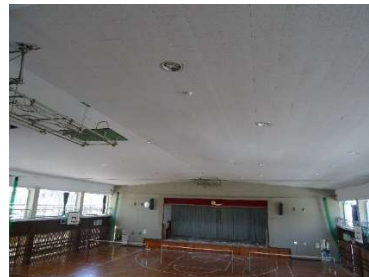
Interior view (ceiling linings are deflected)

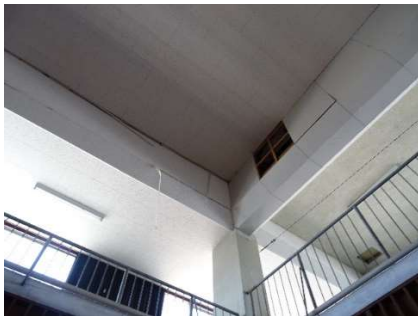
Damage: Due to falling of the ceiling materials and linings, the gym had been closed. The glass of the windows, however, did not break. Some hexagonal cracks, probably due to shrinkage of ageing concrete on the columns of the second floor, were seen. Along those cracks, there were some other cracks, as wide as 1 mm, which were assumed to occur during the earthquake. The shear wall behind the stage of the gym had shear cracks. The pathway to the adjacent building suffered some damage as well.

Damage to the ceiling materials

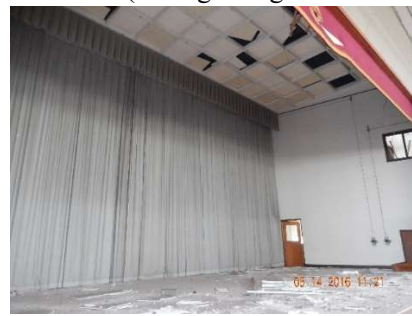
Damage to the ceiling materials of the stage

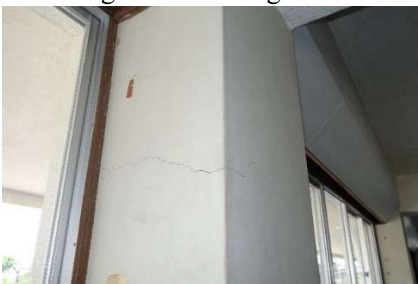
Flexural crack in column of 2nd floor

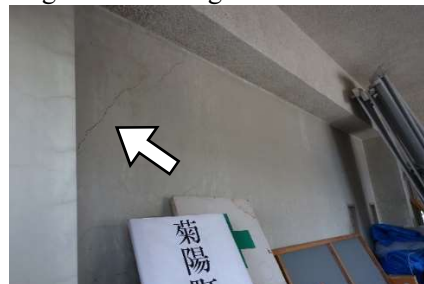
Shear crack in shear wall of 2nd floor

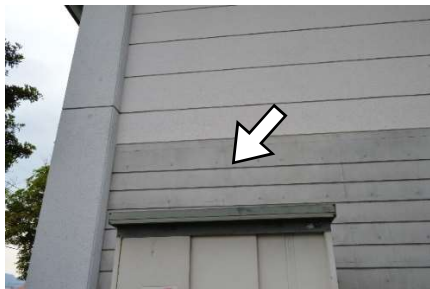
Damage: This building was being used as a shelter. Some ground settlement was seen around the building. Some minor cracks were found in the shear walls along the transverse direction. These cracks were not confirmed as being a result of the earthquake.

Crack in shear wall

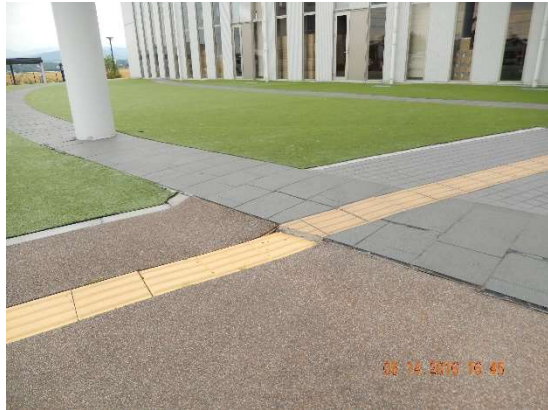
Damage: A crack in the glass facade next to the entrance was seen. Some settlement in the surrounding ground was noticed.

Ground settlement

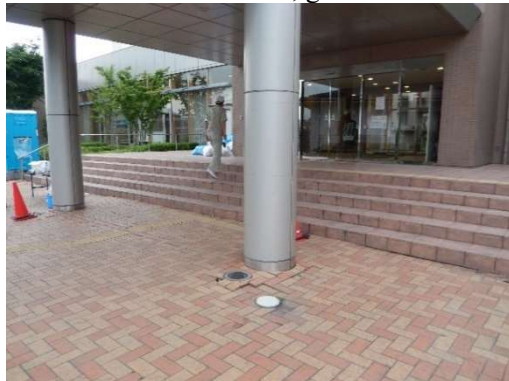
Damage: This building was partially used as an evacuation shelter. No major damage was found from the outside. However, ground settlement as large as 10 cm around the building was observed.

Damage in the external floor.

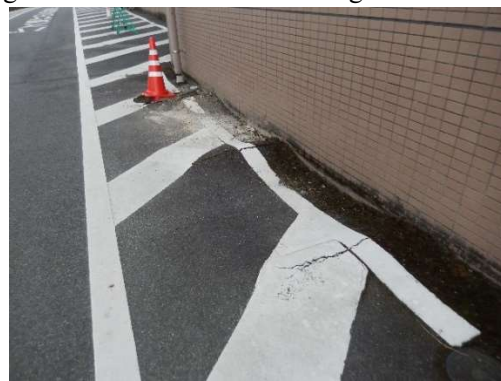
Ground deformation.

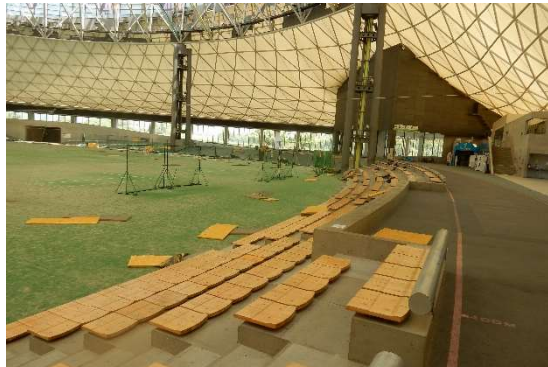
Damage: This facility is currently closed to public. Some concrete spalling occurred in the exterior RC walls of the office building. Ceiling materials in the gym were partially loosened and had fallen down.

Fallen ceiling materials on the ground floor

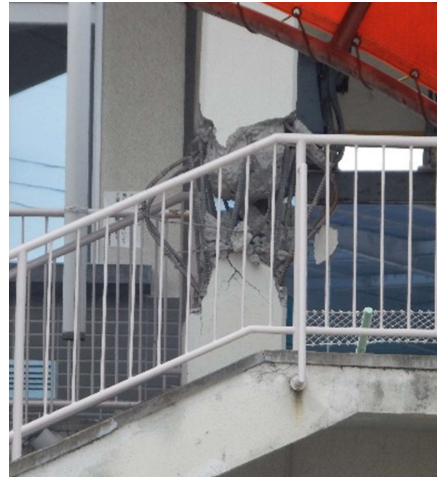
Damage: The whole structure was judged as “unsafe”. A number of RC columns of the stand which was built in 1968 suffered shear/flexural failure. In some steel frame structures the infill panel were either cracked or shattered.

Shear collapse of column

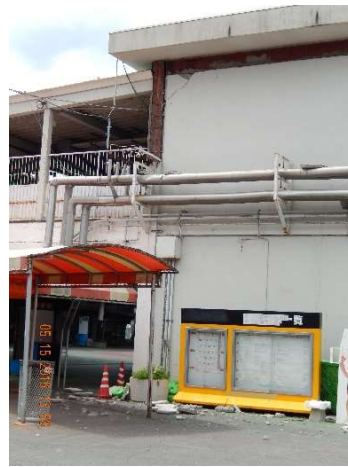
Damage to infill panel of steel structure and crack in the first floor walls

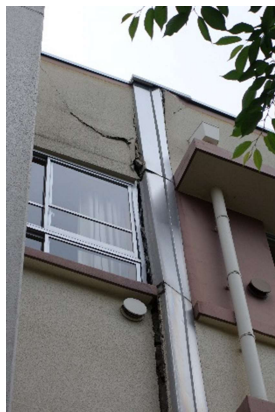
Damage: Damage at the expansion joint was significant. Some diagonal cracks were observed at the joints of the outer frames, but it was not confirmed whether these occurred due to the earthquake or not. Shear cracks were noticeable in the longitudinal direction of the building where the external PCaPC frames were attached to the existing building.

Damage at expansion joint

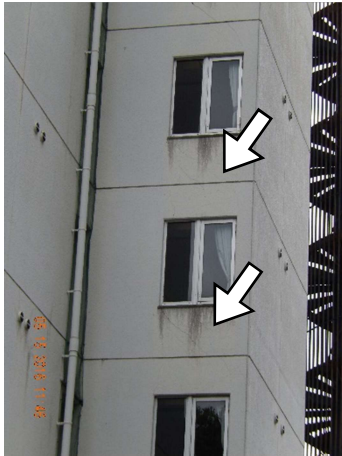
Damage: The building was apparently vacant. Extensive cracks in the RC walls between window openings were observed. In addition, some diagonal cracks were noticed in the beam above the entrance.

Cracks in exterior RC walls between window openings

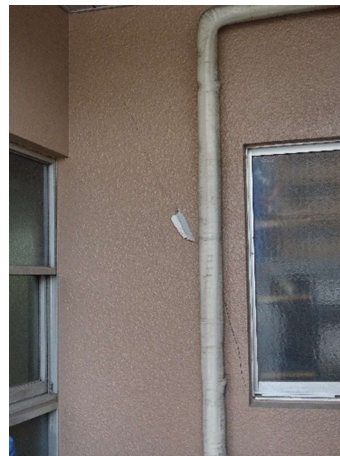
Damage: The building was open to public. Shear cracks were found in the external wall of the first story and the retrofitting frames. Moreover, cracks in the beam-column connections were seen.

Shear crack in external wall of first floor

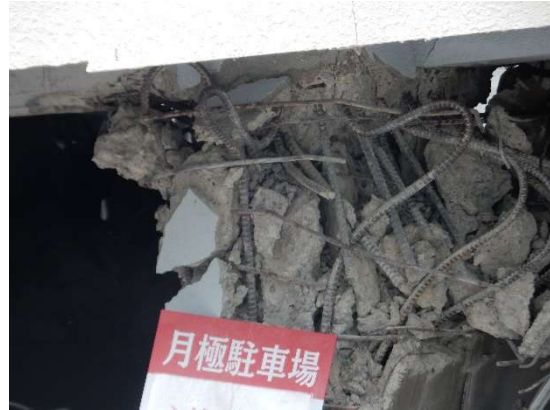
Damage: The first floor collapsed. Lap splices of steel reinforcement were seen at the top of columns of the 1st floor.

Lap splices at the top of the collapsed column in the 1st floor

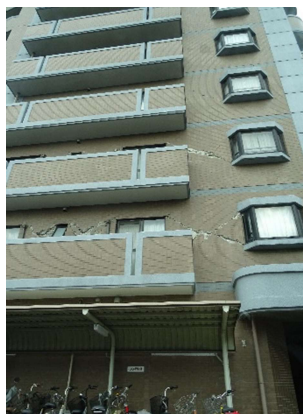
Diagonal cracks in non-structural RC wall (Kumamoto city, East district)

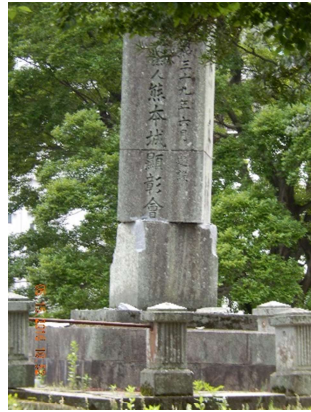
Rotation of stone monument

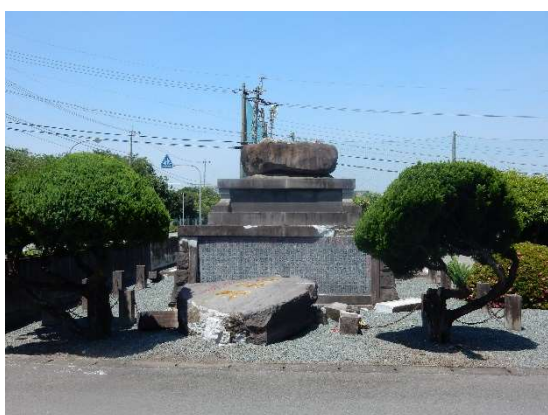
Collapse of a stone monument (Kikuyo town)

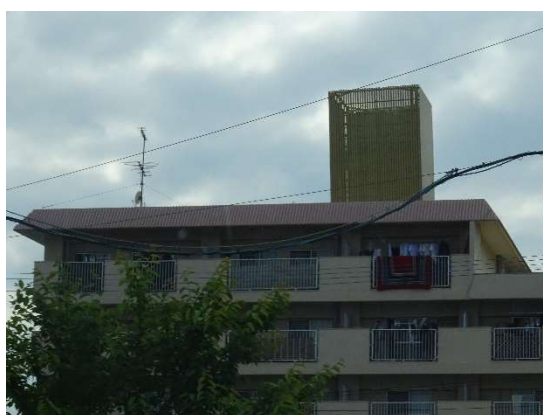
Tilting of a roof water supply (Kumamoto city, East district)
